## ASOS MODIFICATION NOTE 33 (for Electronics Technicians)

SUBJECT : ACU Memory Firmware Version 2.4 and ACU CPU Firmware 1.81

PURPOSE : Firmware for Meteorological Aviation Report (METAR).

EQUIPMENT AFFECTED : ASOS Acquisition Control Unit (AACU)

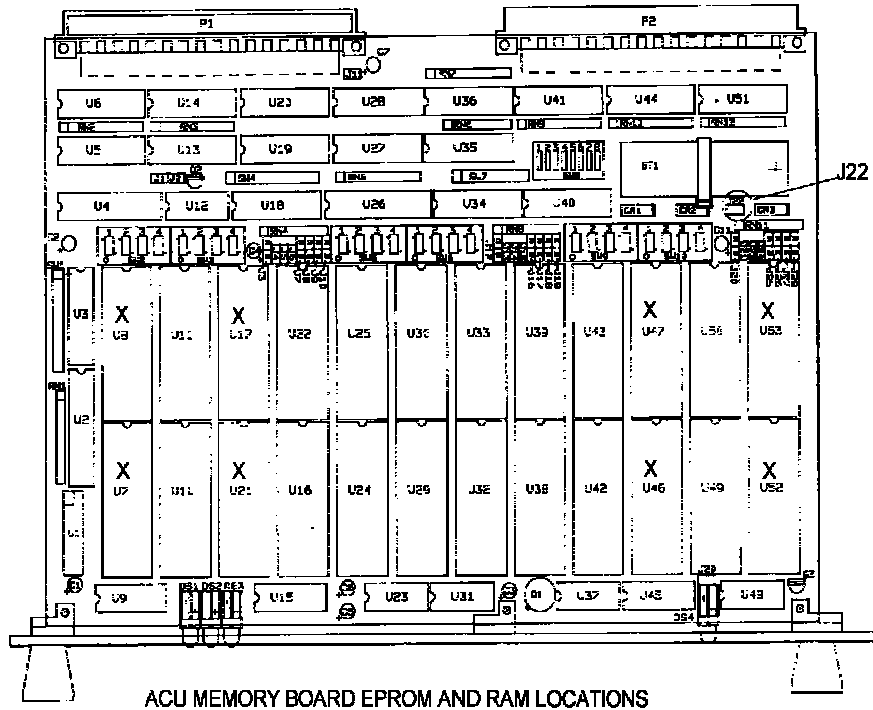
FIGURE 1

Figure 1 also identifies the four additional RAM chips (U46, U47, U52 and U53). The RAM chips are 32-pin DIP CMOS devices, each providing 128K x 8 bits of storage. There will be no jumpers or switch setting changes to the board. **One RAM chip is added to the top of the clock socket/chip (U52). This causes the chip to protrude into the next card slot position.**

ACU MEMORY BOARD EPROM AND RAM LOCATIONS

EPROM  
U7  
U8  
U17  
U21

RAM  
U46  
U47  
U52  
U53

11. Using the IC insertion tool, remove the new EPROM ICs from protective packaging and insert them into the ACU memory board sockets in accordance with the following chart. Ensure that the EPROMs are installed with pin 1 (as identified by notch in top of IC) oriented toward board connector P1 and P2 as shown on Figure 1.

12. Step 12 and 13 can be skipped if ACU memory version 2.23 or later has been installed. Using the IC insertion tool, remove the RAM ICs from protective packaging and insert them into the ACU memory board sockets U46, U47, U52 and U53. Ensure that the RAMs are installed with pin 1 (as identified by notch in top of IC) oriented toward board connector P1 and P2 as shown on Figure 1. U52 already has a clock chip installed. **DO NOT REMOVE THE CLOCK CHIP.** Install the RAM chip on top of the clock chip.

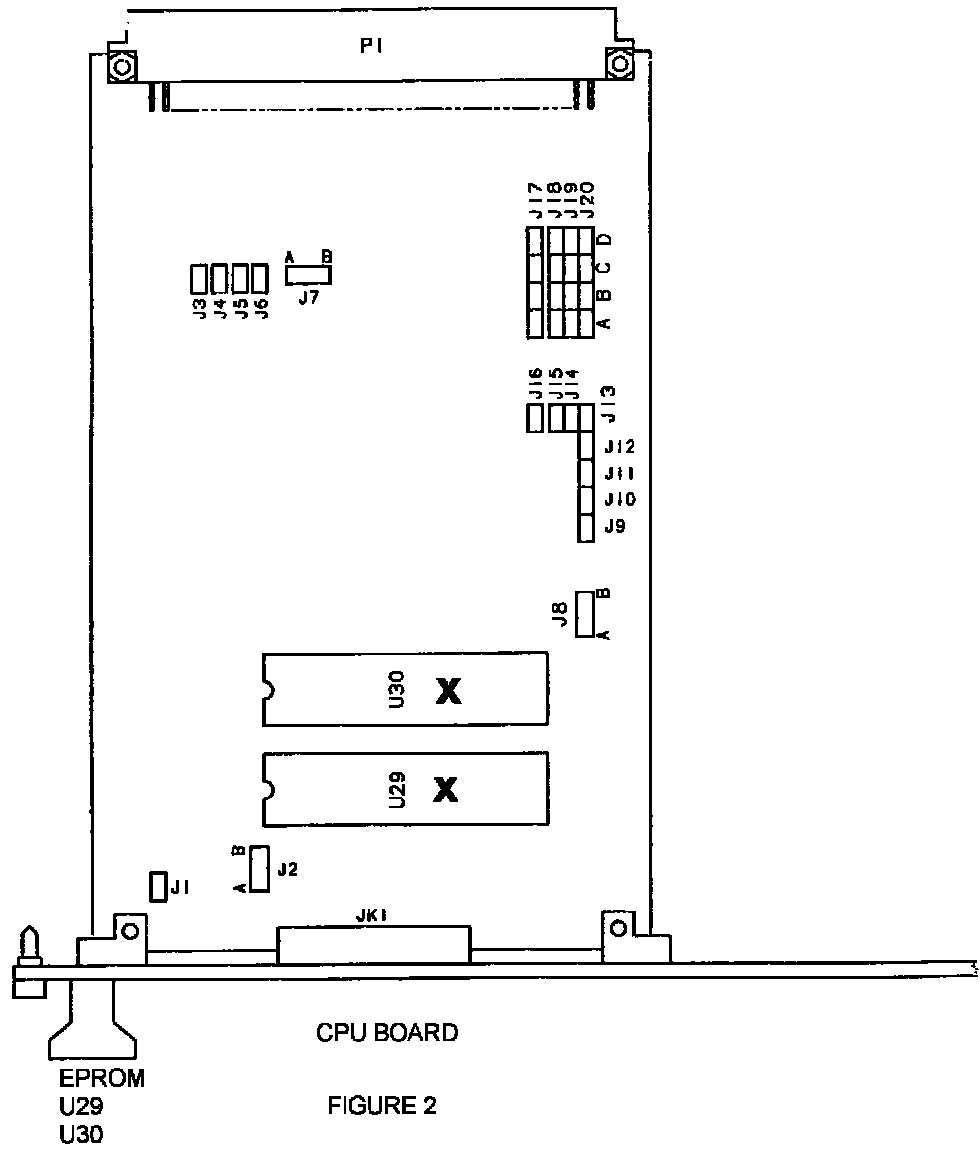
All ASOS operating software is contained on two EPROM ICs on each ACU CPU board 1A2A1 and 1A2A2. Figure 2 illustrates the ACU CPU board and identifies the two EPROMs (U29 and U30). The EPROMs are 28-pin DIP CMOS devices, each providing 256K x 8 bits of storage. Upgrading pSOS ASOS software requires only replacing the two EPROMs on each ACU CPU board with higher revision level ICs.

17. Use a small flat blade screwdriver and tighten the captive screws located at top and bottom of boards and blank panels.
18. If required, remove the new EPROM ICs from the protective packaging. Use an IC insertion tool to insert the EPROMs into the ACU CPU board's sockets (1A2A1 and 1A2A2) in accordance with the following chart. Ensure that all the EPROMs are installed with pin 1 (as identified by notch in top of IC) oriented toward the top of the ACU CPU board as shown on Figure 2.
